# Manhole Inspection Summary

Manhole # S11CC2014MH

Insp Date: **7/28/06 10:44 AM**

**Location** Address: **2311 CROSS COUNTRY BLVD**

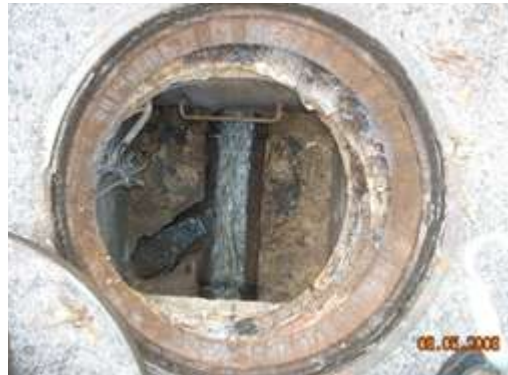
Top View

Corroded steps. Bench and Channel debris.

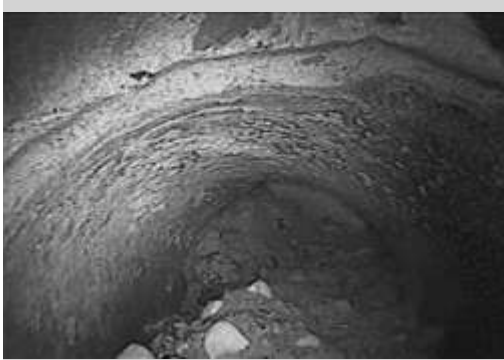
Inside the I9

Stub.

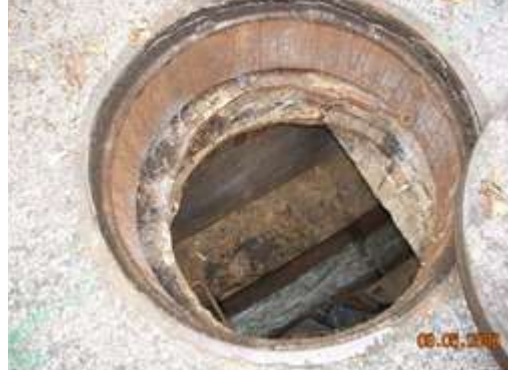
Defect

Frame leaks. Frame offset. Corbel deterioration and infiltration. Barrel infiltration.

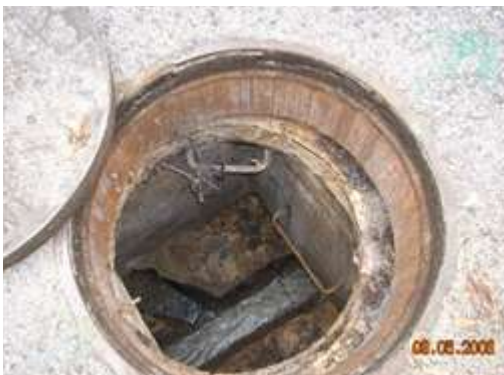
Defect

Frame leaks. Frame offset. Corbel deterioration and infiltration. Barrel infiltration.

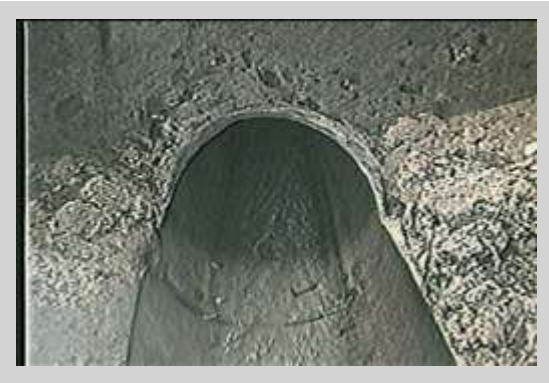
### 10 in. Circular Gravity Sewer Pipe Out @ 12 O'Clock

Infiltration: **None** Pipe Seal Cond: **Cracked**

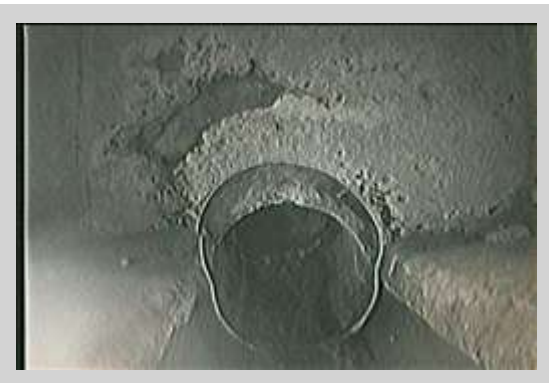
### 10 in. Circular Gravity Sewer Pipe In @ 6 O'Clock

Barrel deterioration and infiltration.

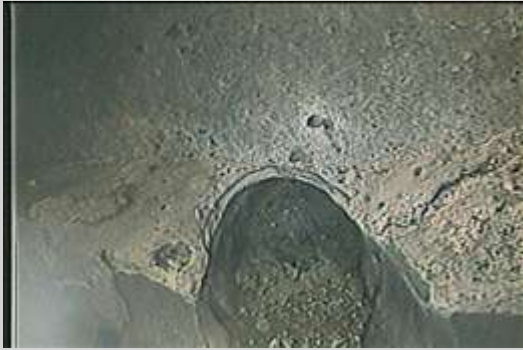
Pipe In @ 9 O'Clock

Infiltration: **Evidence**

Connects To: **Stub connection / abandoned**
